16TH SEMINAR

lessons learnt from industrial accidents

May 20 and 21, 2025
Metz

Summary

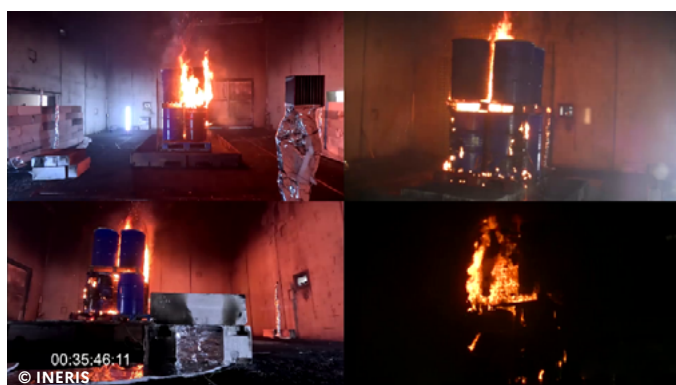
- * thermal runaway propagation test on a stack of storage boxes. This is the same test as before but in a configuration which makes it possible to observe the propagation from box to box.

Propagation tests on storage drums

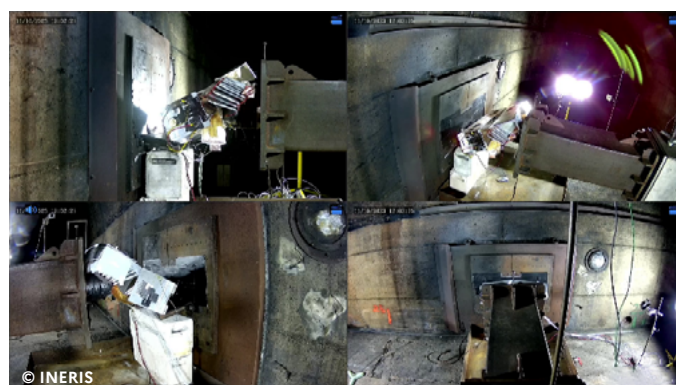
- Test to search for the possible causes of thermal runaway on stored modules (falls, internal defects). For this purpose, the module was subjected to a compression test (see photo below) which involves crushing it with a ram, and tests to simulate internal defects in the module: a nail test (which involves causing an internal short circuit by passing through the electrochemical cell with a nail) and a localised heating test (which involves applying great heat to the electrochemical cell on a small surface area).

Compression test on modules

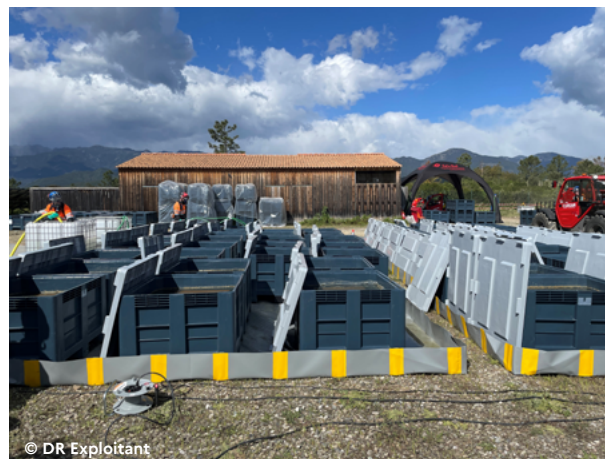
With regard to dismantling of the batteries, which was complex due to the presence of modules that were still charged (65%), the operator commissioned INERIS to establish a protocol in order to ensure and secure the dismantling operations. This intervention protocol defines the means of protection for technicians, the procedures for neutralising the modules in a bath of brine and for their transport with a view to their disposal. Eight technicians trained in interventions on electrical installations and in chemical risks worked in SCBA (self-contained breathing apparatus) for 72 hours to disconnect the batteries and position them in 3% brine baths placed in the open air. Each battery was tracked and its voltage was monitored until complete electrical discharge was reached (0 Volt after about 4 hours' immersion). Each immersion tank was regularly checked for the following factors: temperature of the briny water, surface temperature of the tank, releases of hydrogen (H_2), oxygen (O_2), carbon monoxide (CO), hydrogen sulphide (H_2S) and Volatile Organic Compounds (VOCs). Once it had been electrically discharged, each battery was drained and placed in a box certified 4GV (international carriage of dangerous goods by road - ADR) for shipment to a treatment centre on the continent (Isère region). In all, 4 convoys with about 10 tonnes of batteries were completed by lorry (including transit on boats between Bastia and Marseille).

Battery inerting operation

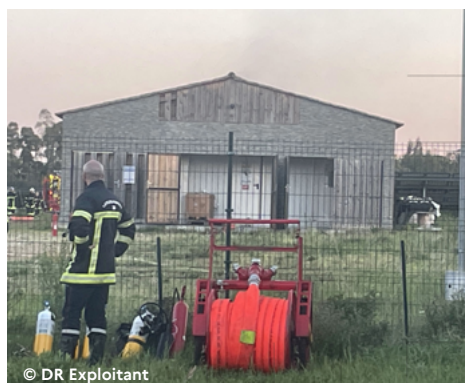
Release of yellowish fumes during the lithium-ion battery fire

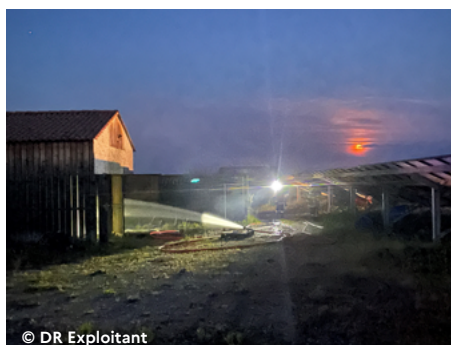
The firefighting strategy employed, notably due to the availability of water in the vicinity of the site, consisted in massively spraying the burnt container with water while protecting the adjacent second container and transformer (about 15,000m³ of water used over the duration of the event given that the fire broke out again many times). While the massive spraying made it possible to prevent widespread thermal runaway and to limit the release of fumes, this intervention strategy nevertheless raises a number of questions.

Massive spraying with water

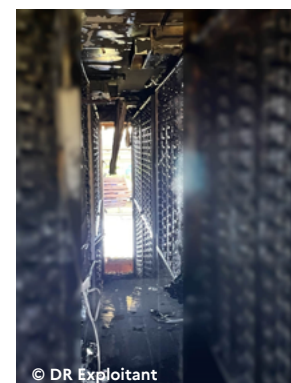
In addition to the legal and insurance appraisals, a BEA-RI investigation was initiated. The BEA-RI report concluded that the fire could have been caused either by an internal defect of a module or by the presence of water inside the container (water produced by the air conditioning system). An examination of the recorded data rather suggests a module defect.

Battery container after fire

- the choice of modules: give priority to equipment designed to limit the propagation of thermal runaway (standard UL 9540) or better protected from humidity (high degree of protection);

- the location: install containers in such a way that fire does not spread to an adjacent container or to buildings, so that the strategy of "letting them burn" can be a feasible option. These distances can be reduced if protection systems are planned (e.g., fire-resistive wall). Regarding this, the container location areas must be regularly maintained to prevent the fire from spreading to the vegetation;

- the design of air conditioning systems: special attention must be paid to the design of these systems to deal with the issue of condensation of water, notably by restricting the passage of elements near electrical equipment. Moreover, aircon systems must be monitored and maintained regularly during the life of the container;

- the fire safety plan: it should be produced in conjunction with the public emergency services to define the required water resources.

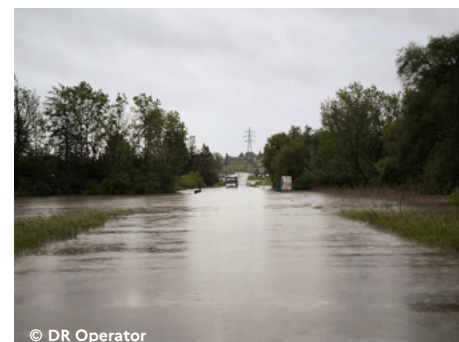
Flooded county road

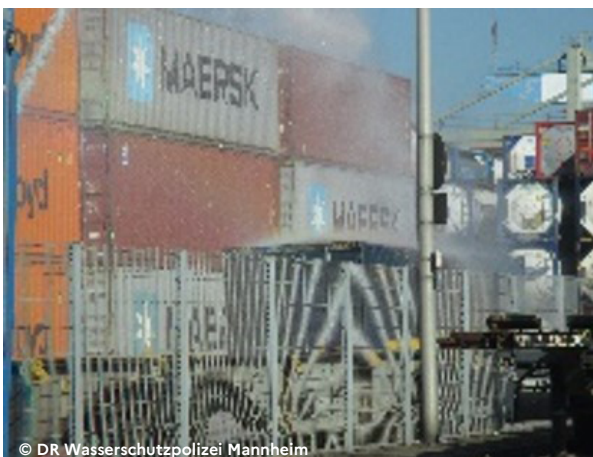
Cooling the ISO-container with a water spray

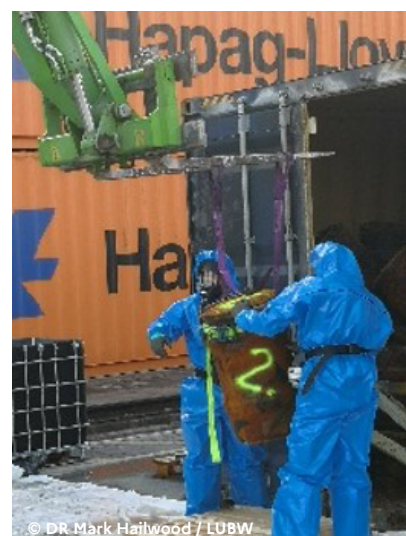
Recovering the drums from the ISO-container

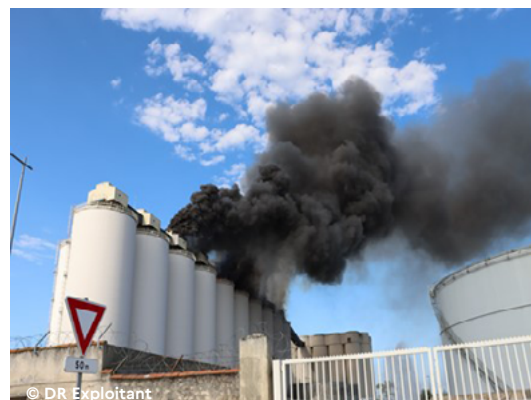
Gallery fire

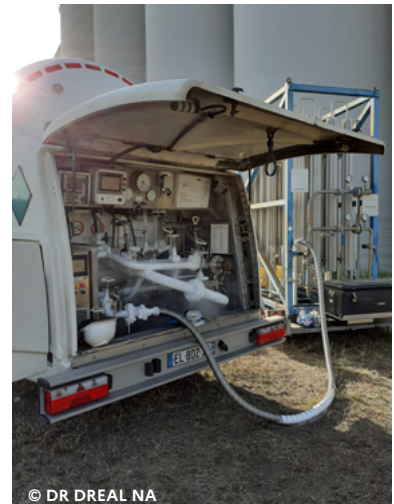
Nitrogen inerting
