16TH SEMINAR

lessons learnt from industrial accidents

May 20 and 21, 2025
Metz

Summary

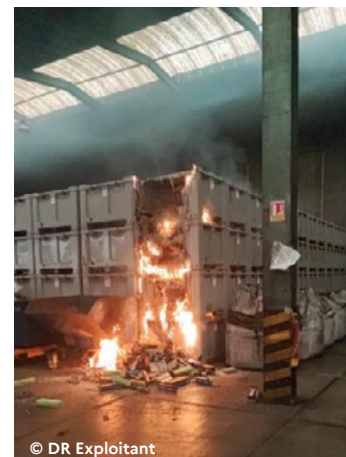
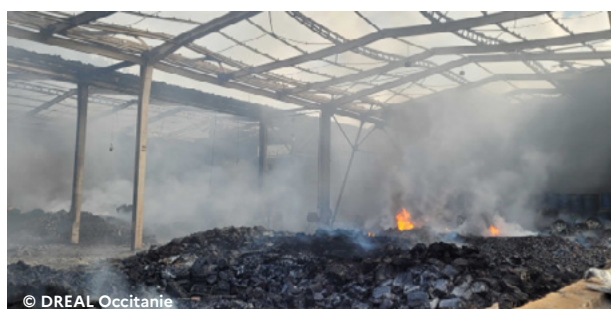
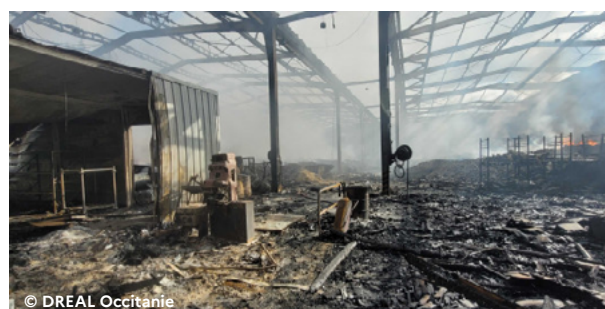
The building was completely destroyed and the facility was shut down. The event had major economic consequences for the facility, but also for the region, still deeply marked more than one year later (short-time working, lost contracts, etc.). On the human and health level, the event caused one slight injury (an employee indisposed by the smoke) and gave rise to 44 reports to healthcare professionals. A health and environmental monitoring plan was implemented to assess the consequences. More than 1,000 measurements were made in surface water, in groundwater, in a swimming pool, in the air, in the fallout of dust, in plants and in honey. A few detections of PM 10 are observed, followed by a return to normal. The decision to stop monitoring was taken in March 2025, i.e. more than one year after the fire.

A volume of about 6,000m³ of hazardous liquid effluents, consisting of firefighting water and rainwater that had come into contact with debris from the fire, was transported to a remote treatment site. The residue of burnt batteries is still on site pending transfer to the adjacent site.

An analysis of the video surveillance recordings quickly ruled out certain hypotheses concerning the source of the fire, particularly that of a malicious act or a falling storage box. The hypothesis of thermal runaway of a mobile phone battery stored in a pallet box was therefore considered the most likely. The precise cause of the thermal runaway has not yet been able to be determined, although it could have been due to battery damage or wear, or else a short circuit.

- the response time: as in most fires, the earlier battery thermal runaway is detected and taken charge of, the greater the chances of limiting spreading of the fire. In particular, the time for verification should be limited insofar as possible, e.g. by using video surveillance;
- the fire extinction resources: the massive use of water is an effective way of limiting the development of a Li-ion battery fire;
- the storage conditions: these play an essential role in the propagation of a thermal runaway: storage in metal drums provides more protection than storage in plastic boxes, by limiting the combustibility of the container and ensuring a form of tightness. The literature also gives grounds for preferring the storage of weakly charged batteries and limiting their period of storage, especially in the case of vehicle batteries for which the state of charge is more easily manageable.

This accident confirms the fact that the regulations on Li-ion batteries must be revised just when an increasing need for recycling of these batteries is emerging. The storage conditions and firefighting facilities should be adapted to the specific features of this equipment.

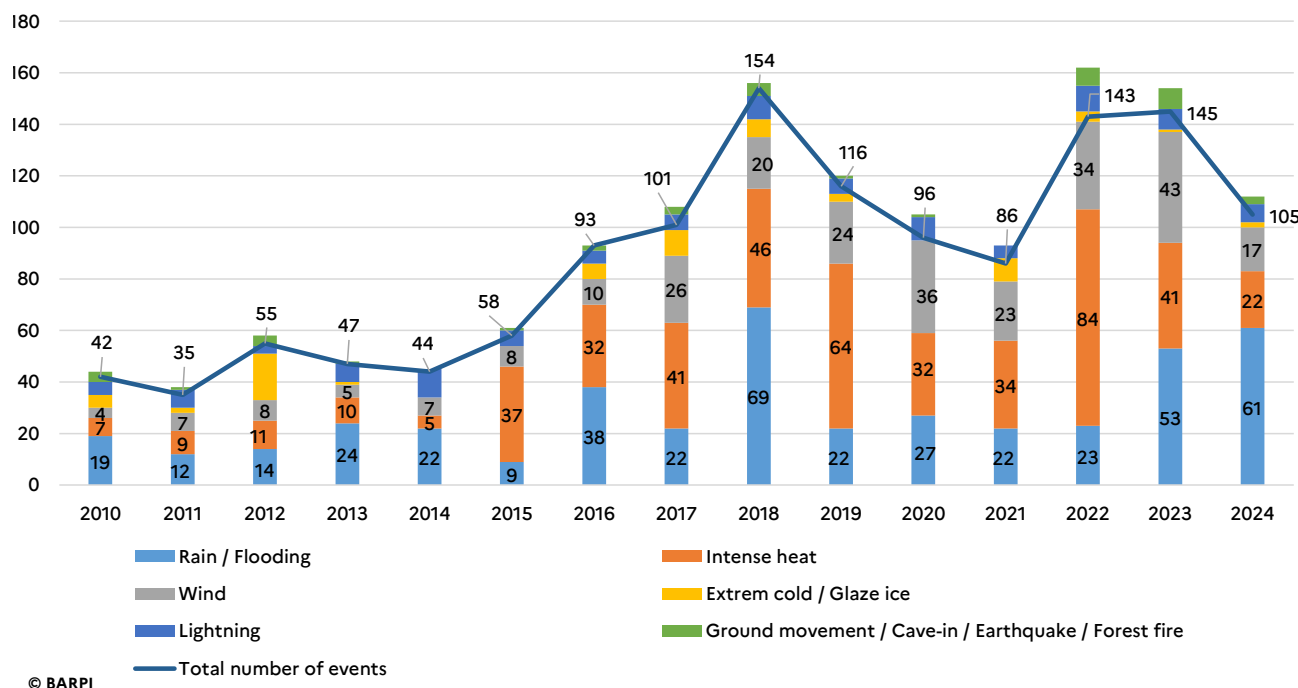
Incidents and accidents in France due to a natural hazard

This chart shows all the events recorded in the ARIA database regarding facilities of the classified type (whatever the regime) in France between 2010 and 2024¹ due to a natural hazard. The events (incidents or accidents) identified include those for which the natural hazard is the cause of the event, but also those for which it contributed to or exacerbated the event.

Between 2010 and 2018, a significant increase was observed in the incidence rate, followed by a period without any notable tendency, but with major annual variations. This trend is fostered mainly by extreme heat and wind and by rain or flooding; the latter accounted for a total of 437 events out of the 1,320 identified.

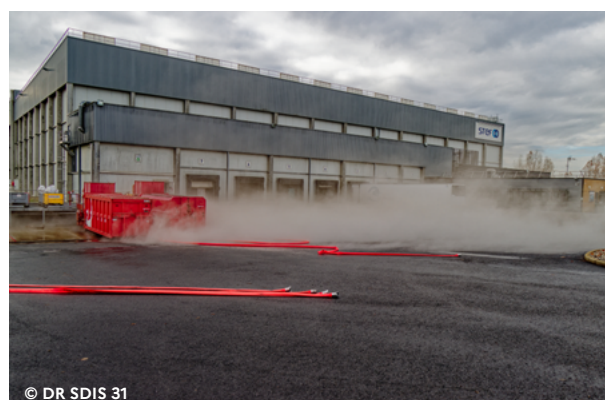
The water retention basin valve had been closed manually. The firefighting water reservoir, meanwhile, was unusable by the firefighters. The ammonia refrigeration system was not impacted. Moreover, the firefighters were faced with the drivers' refusal to leave the platforms without transport documents.

At around 12.10 pm, the main source was identified, and the firefighters activated the smoke vents. These vents, mounted on the roof, lead to the technical plenum and had no effect on the removal of smoke in the compartment.
